Re: First Quarter 1999 Performance Report
Avery Landing Recovery System

Hart Crowser is pleased to present the First Quarter 1999 Performance Report for the Avery Landing free product recovery system. This letter report presents the first quarter groundwater elevations, product thickness measurements, and recovered free product volume.

Avery Landing First Quarter 1999 Groundwater Flow

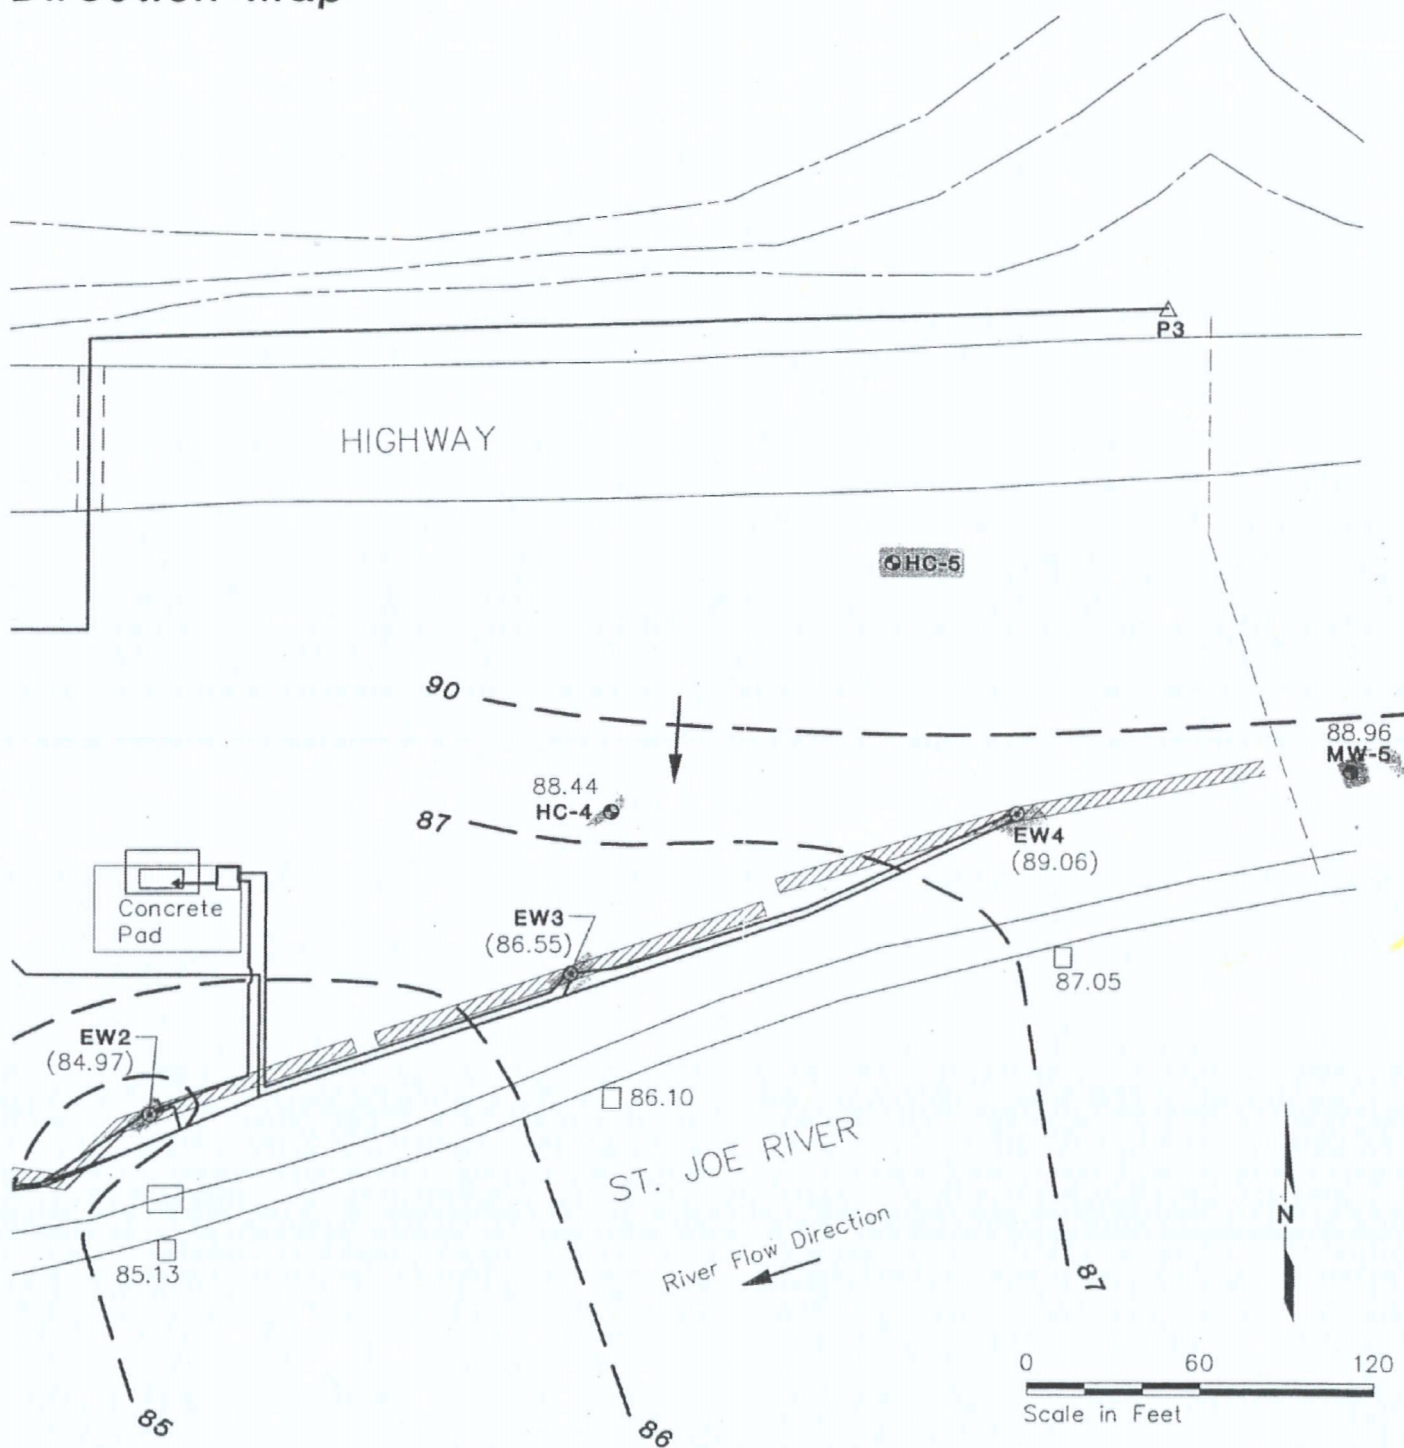
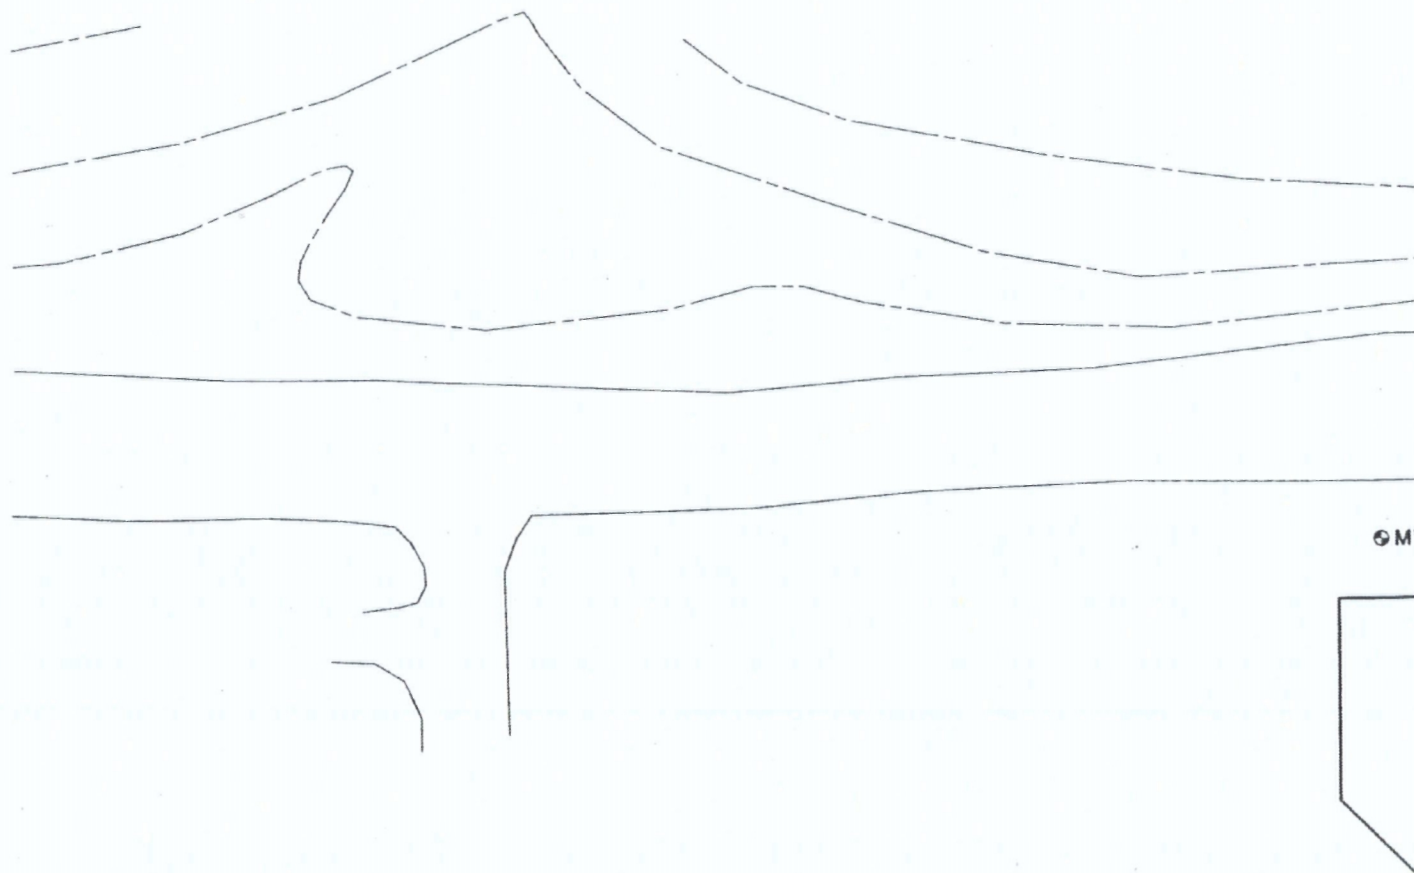
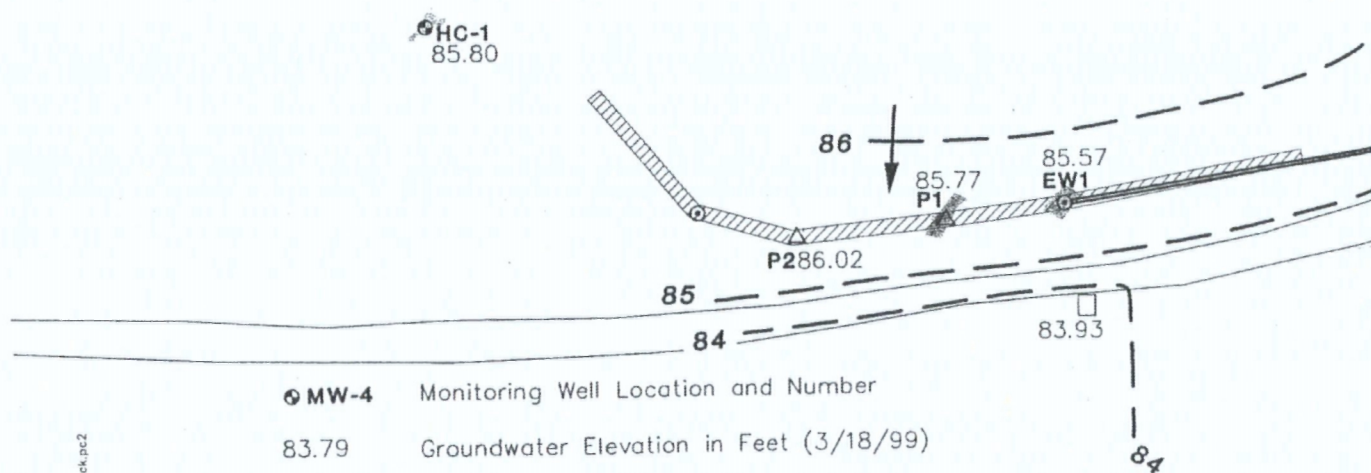
Figure 1

- ▶ EW-1 is no longer in use, as described in the 1998 Annual Report;
- ▶ EW-2 was operating and maintaining groundwater capture as indicated on Figure 1;
- ▶ EW-3 was operating, but was not maintaining groundwater capture. This could be the result of high groundwater flow due to spring runoff; and
- ▶ EW-4 was not operating during the March 18 site visit because of pump failure. During the site visit on April 6, 1999, the motor and pump had been replaced, and EW-4 is currently operating.
